**Flood Control Project Maintenance
Levee Inspections****LMA District Cover Sheet****Spring 2013 Levee Inspection Results****Sutter Maintenance Yard East Levee Sacramento River**

Spring 2013 Levee Inspection Results

Sutter Maintenance Yard East Levee Sacramento River

Levee Inspection Report By Mile - Spring 2013

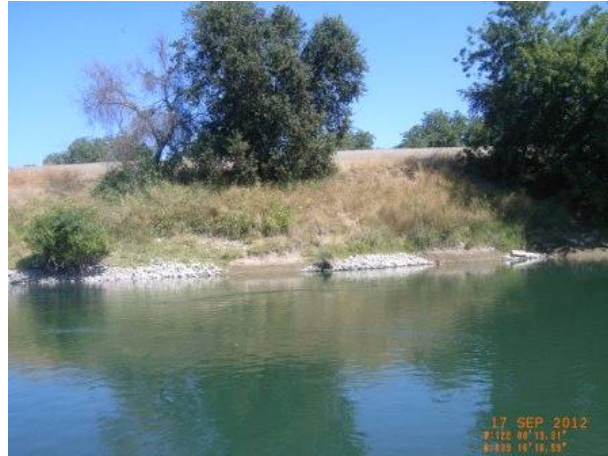
rduffey_s_20130225_265.jpg

USACE 2012 Photo #1

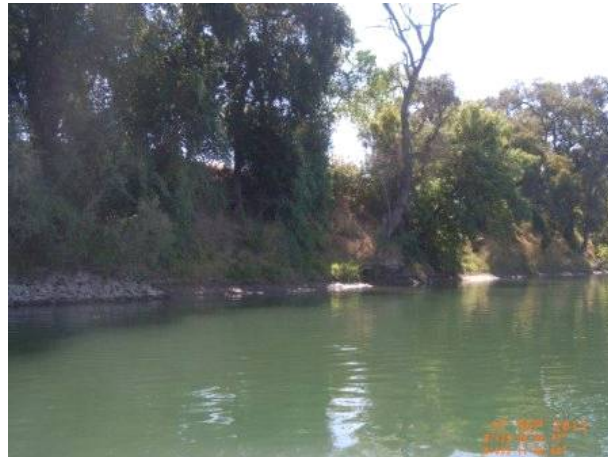
rduffey_s_20130225_266.jpg

Levee Mile Report Line	24
Start Levee Mile	11.51
End Levee Mile	11.51
Location	Water Side
Category	Supplemental
Item	USACE Erosion Survey

USACE 2012 Photo #1

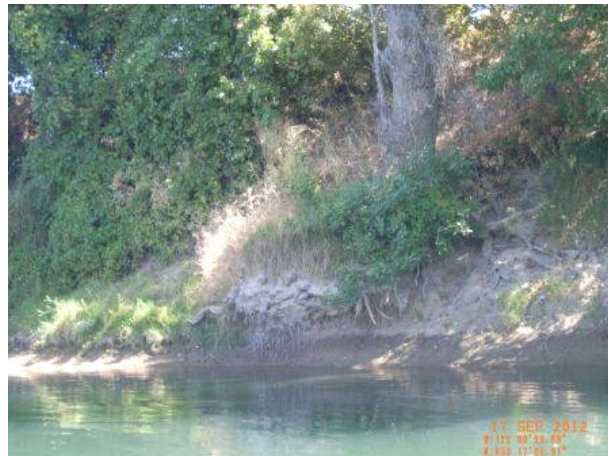
rduffey_s_20130225_267.jpg

Levee Mile Report Line	24
Start Levee Mile	11.51
End Levee Mile	11.51
Location	Water Side
Category	Supplemental
Item	USACE Erosion Survey

USACE 2012 Photo #2

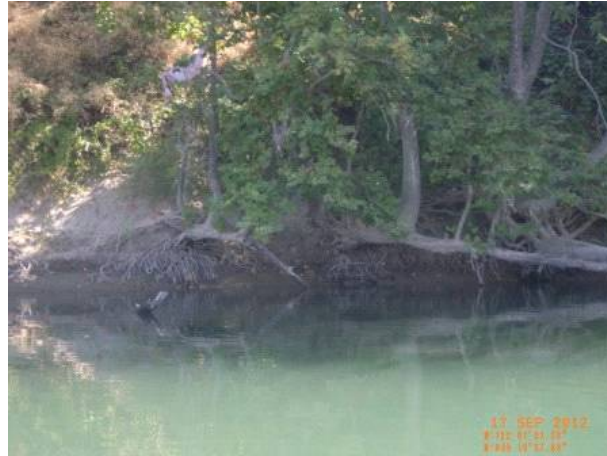
rduffey_s_20130225_268.jpg

USACE 2012 Photo #3

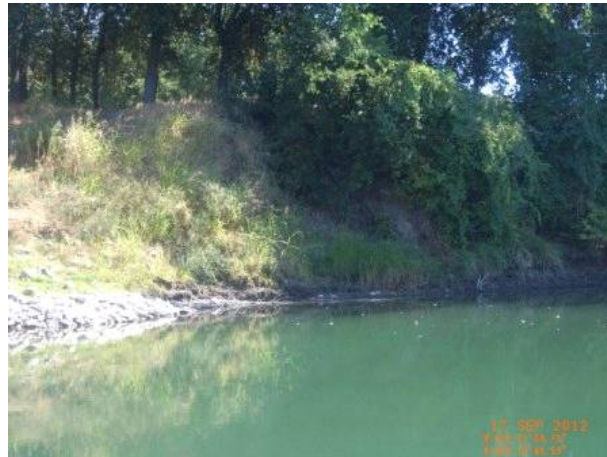
rduffey_s_20130225_269.jpg

Levee Mile Report Line	24
Start Levee Mile	11.51
End Levee Mile	11.51
Location	Water Side
Category	Supplemental
Item	USACE Erosion Survey

USACE 2012 Photo #4

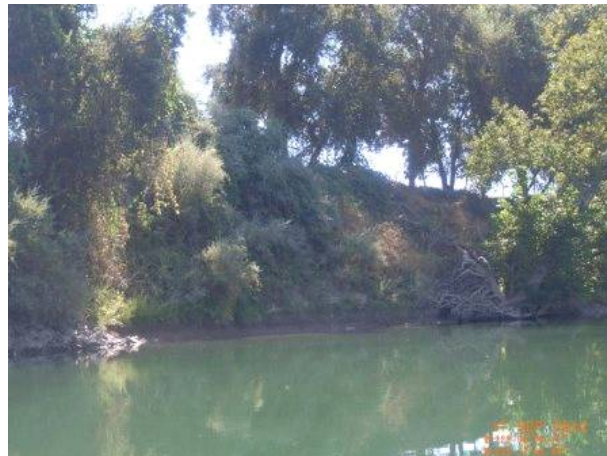
rduffey_s_20130225_270.jpg

Levee Mile Report Line	26
Start Levee Mile	11.83
End Levee Mile	11.89
Location	Water Side
Category	Supplemental
Item	USACE Erosion Survey

USACE 2012 Photo #1

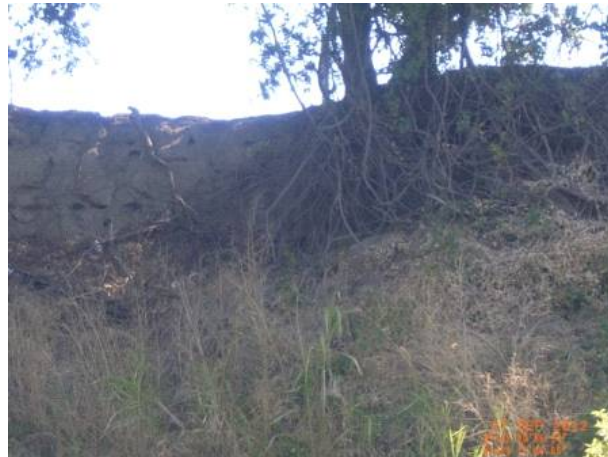
rduffey_s_20130225_272.jpg

Levee Mile Report Line	26
Start Levee Mile	11.83
End Levee Mile	11.89
Location	Water Side
Category	Supplemental
Item	USACE Erosion Survey

USACE 2012 Photo #3
